**EMERGENCY SPILLWAY PERFORMANCE,  
UPPER RED ROCK CREEK WATERSHED,  
OKLAHOMA**

**ARS-S-108**

**May 1976**

By W. O. Ree<sup>1</sup>

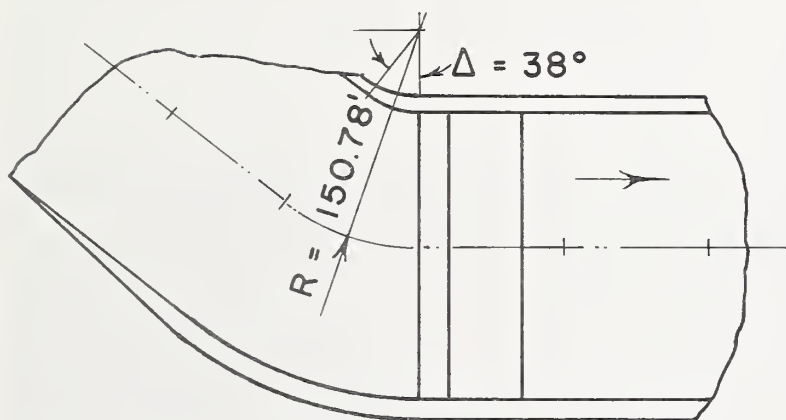
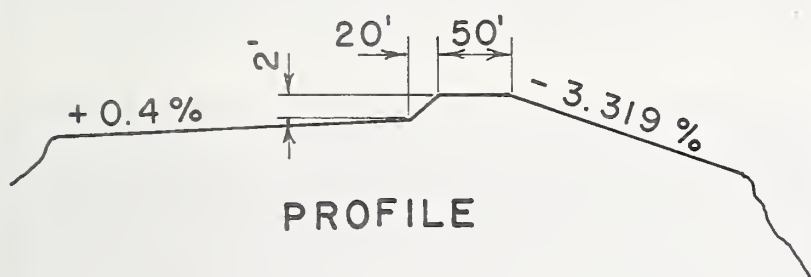
FIGURE 2.—Emergency spillway dimensions, site 24.

The emergency spillway is an earth channel around the right end of the dam (fig. 2). It was excavated in the red clay and shale of the site, topsoiled to a depth of 6 inches, and planted with ber-

mudagrass. At the time of the survey the noneroded area of the spillway had a poor stand of short, heavily grazed bermudagrass and a scattering of broomweed. The flow retardance was judged to be class E, based on the criteria in the Soil Conservation Service handbook.<sup>2</sup>

During the storm the water surface in the reservoir rose to a peak of 1.6 feet above the emergency spillway crest. The flow rate at this head is estimated to have been 730 cubic feet per second. (The procedure for making this flow estimate is given in appendix A.)

What effect did this flow with a maximum mean velocity of about 6.7 feet per second have on the emergency spillway? This question is best answered by examining the photographs of the emergency spillway after the flow. Figure 3 is a view of the area

The site 24 spillway started to erode during a flow event which had a peak mean velocity of 6.7 feet per second. The spillway appeared to have been heavily grazed, and this may have been responsible for its condition. Cattle trails and “stomp” areas were present in the spillway at the time of inspection. Therefore, it is reasonable to assume that the eroded areas also had suffered from similar cattle activity.

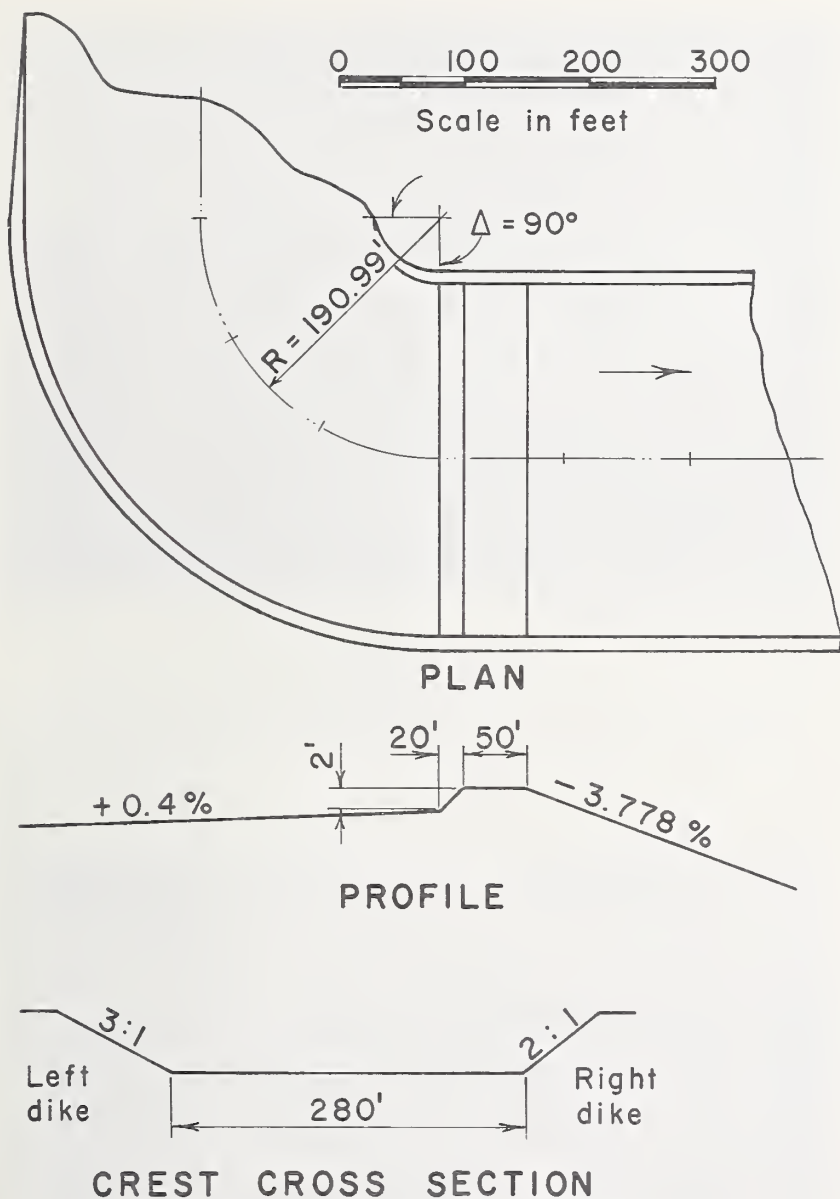
FIGURE 7.—Emergency spillway dimensions, site 25.

The emergency spillway is at the right end of the dam. Its dimensions are shown in figure 7. A minimum of 6 inches of topsoil had been placed on the spillway surface after excavation and shaping. At the time of the flood the spillway had a very uniform, good cover of bermudagrass, with a scattering of a short, fine-leaved grass and broomweed. The spillway had been grazed, and the grass was relatively short. Its flow retardance was estimated to be class E.

Runoff from the storm was sufficient to cause flow in the emergency spillway. The water surface elevation reached a maximum of 1.3 feet above the crest of the emergency spillway. The peak outflow rate for this head was estimated to be 767 cubic feet per second (by the procedure described in the presentation of the site 24 data). A water surface profile computation for a discharge of 767 cubic feet per second showed that the slope of the spillway was

The spillway was in excellent condition after the flood. Some slight erosion was evident about 20 feet downstream from the crest and about 40 feet in from the right bank (fig. 8). It is not known whether this eroded area was present before the flood or whether there had been a weak spot in the cover here. An overall view of the spillway is shown in figure 9.

The excellent condition of the spillway should be expected because the flow velocity of 5.6 feet per second is below a suggested permissible velocity of 8 feet per second for a bermudagrass cover on clay soil and slopes of less than 5 percent, as determined from the "Handbook of Channel Design for Soil and Water Conservation" (cited in footnote 2). Uniformity of cross section and cover and moderate grazing can also be given some credit for the fine performance of the spillway.

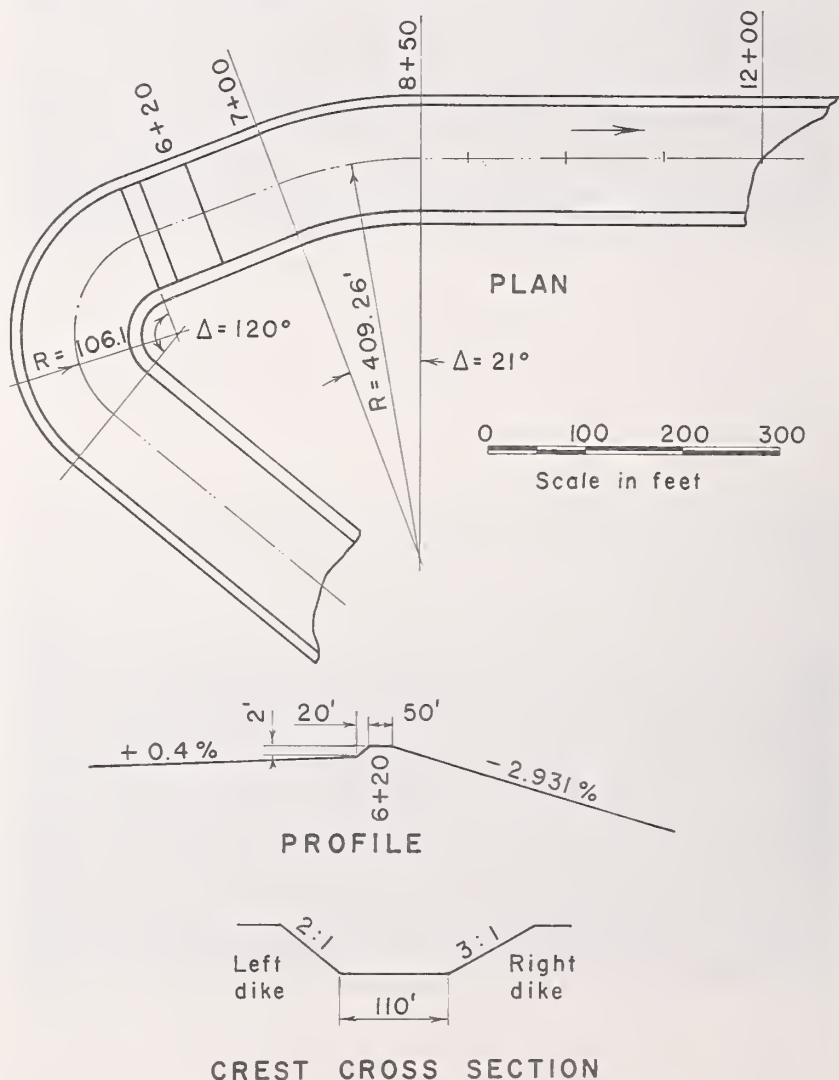
FIGURE 10.—Emergency spillway dimensions, site 30.

The emergency spillway is at the left end of the dam. Its dimensions are shown in figure 10. This spillway has two unusual characteristics. The crest is constructed in fill, probably not more than a foot or two deep, and there is a curve in the downstream reach of the spillway. Topsoil had been placed in the spillway to a depth of 6 inches and bermudagrass was established as a cover. At the time of the flood there was an excellent stand of bermudagrass on the crest and the upper part of the spillway. Toward the lower end of the downstream reach the grass cover was fair to good. The spillway had not been grazed prior to the flood. The overall flow retardance for the cover was estimated to be class C.

First, constructing a spillway in fill is not an acceptable practice and is resorted to only when it is the best alternative solution to a vexing location problem. I have seen only one other spillway with a portion constructed in fill, and this portion failed during a flood event by gullying to a depth of 5 feet. This experience supports the present practice of avoiding fill in the spillway. However, there may be some advantages to using fill in a spillway. The filled area

Third, every effort should be made to avoid placing curves or changes in alinement in steep channels because of the hydraulic disturbances they cause. However, in this case, a curve was the best solution to the location problem. Since the flow was not large enough to be greatly disturbed by the curve, a test of the effect of the curve on the stability of the spillway channel was not obtained during this event.

where the velocity is highest and where the gully starts. (It could eventually reach the center.) A level sill and a low drop structure at the terminal end of the spillway would eliminate the need for the deepening that threatens the stability of the spillway. This would be a practical solution only if the grass could be relied upon to provide protection against erosion in the channel upstream from the terminal structure. If the grass lining is not dependable, there would be no point in using a terminal structure because the spillway could still fail from erosion above the structure. Again, the exploration of this idea is left for future consideration.
